SCREENING SITE INSPECTION REPORT
FOR
MAGNODE PRODUCTS INCORPORATED
TRENTON, OHIO
U S EPA ID OHD004232823
SS ID NONE
TDD F05-8912-016
PAN FOH0500SB

SEPTEMBER 13, 1991

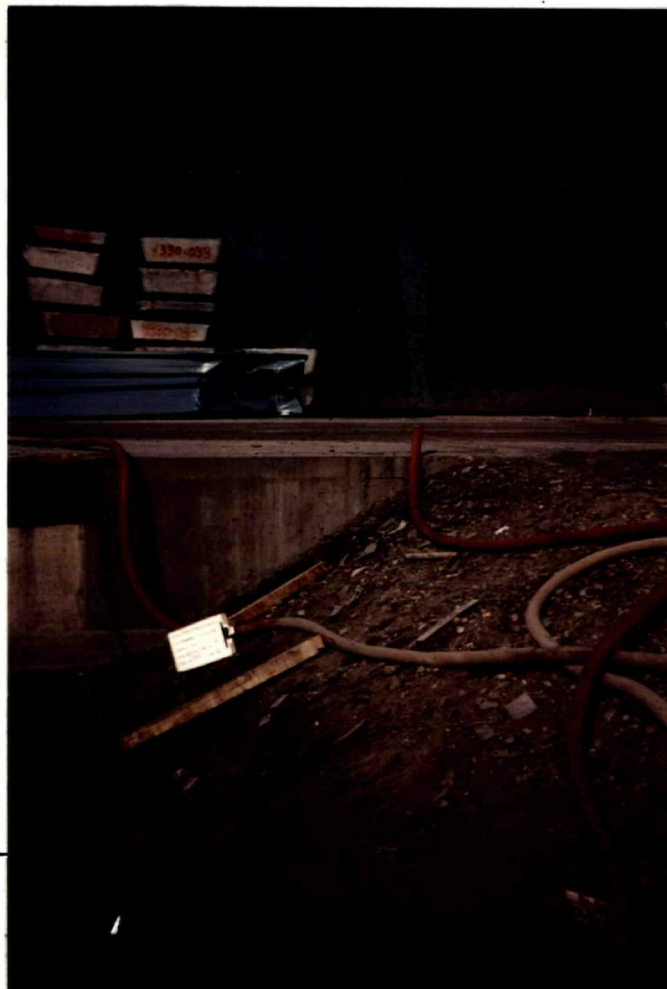
DESCRIPTION: Close-up of sample 52DATE: 10/16/90TIME: 1507DIRECTION OF
PHOTOGRAPH: NorthWEATHER
CONDITIONS: Clear Sky, Warm ~ 70°FPHOTOGRAPHED BY: Mary TierneySAMPLE ID
(if applicable): 52DESCRIPTION: Perspective
view of soil sample 52.

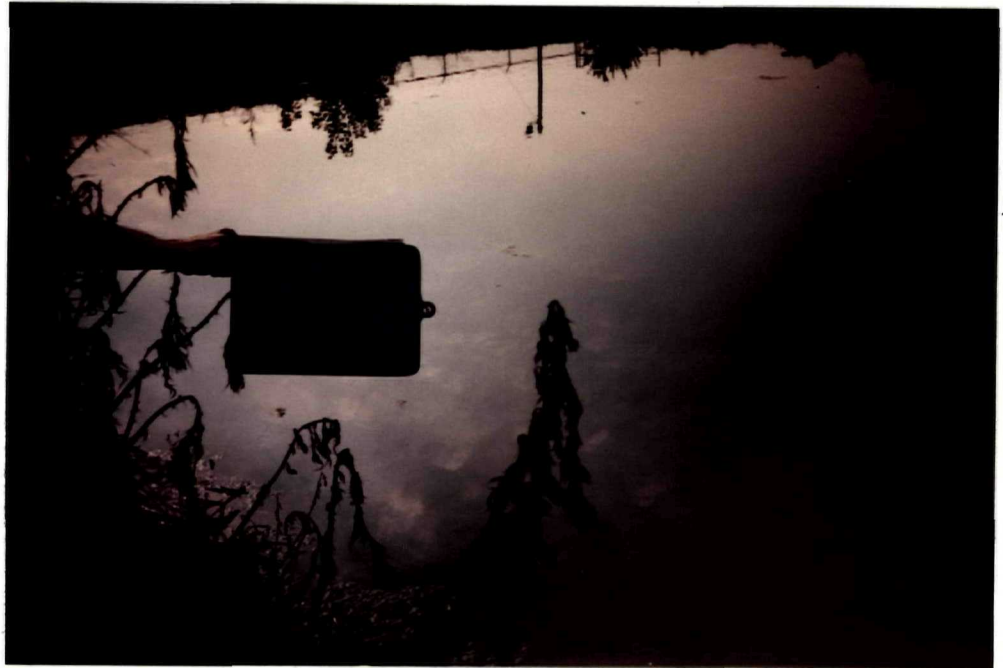
Mary TierneySAMPLE ID
(if applicable):S4DESCRIPTION: Close-up of sample S4

CONDITIONS: Clear Sky, Warm ~ 70°FPHOTOGRAPHED BY: Mary TierneySAMPLE ID
(if applicable): S4DESCRIPTION: Perspectiveview of soil sample S4,

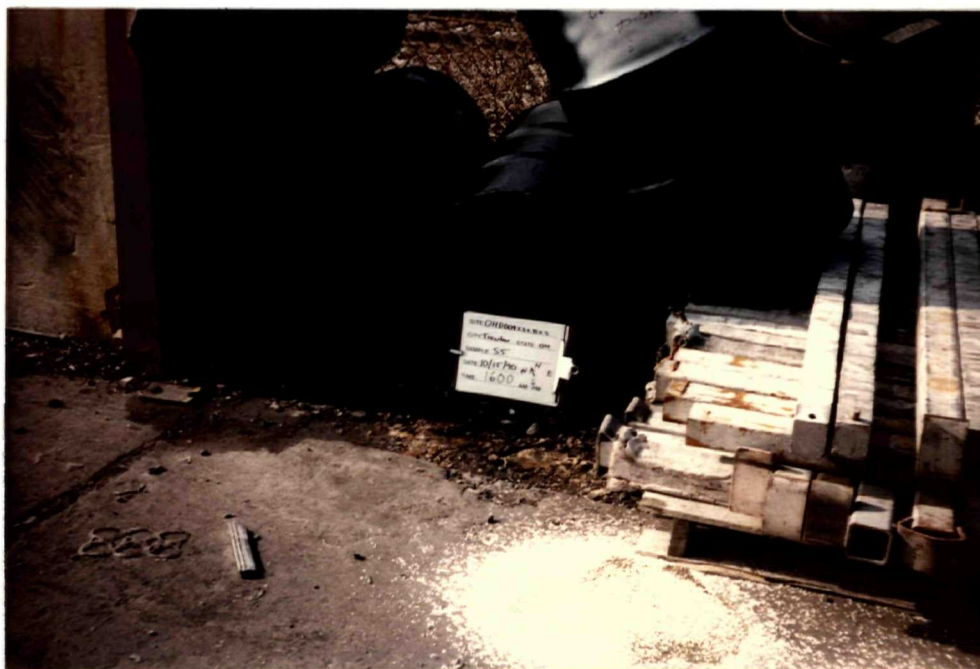
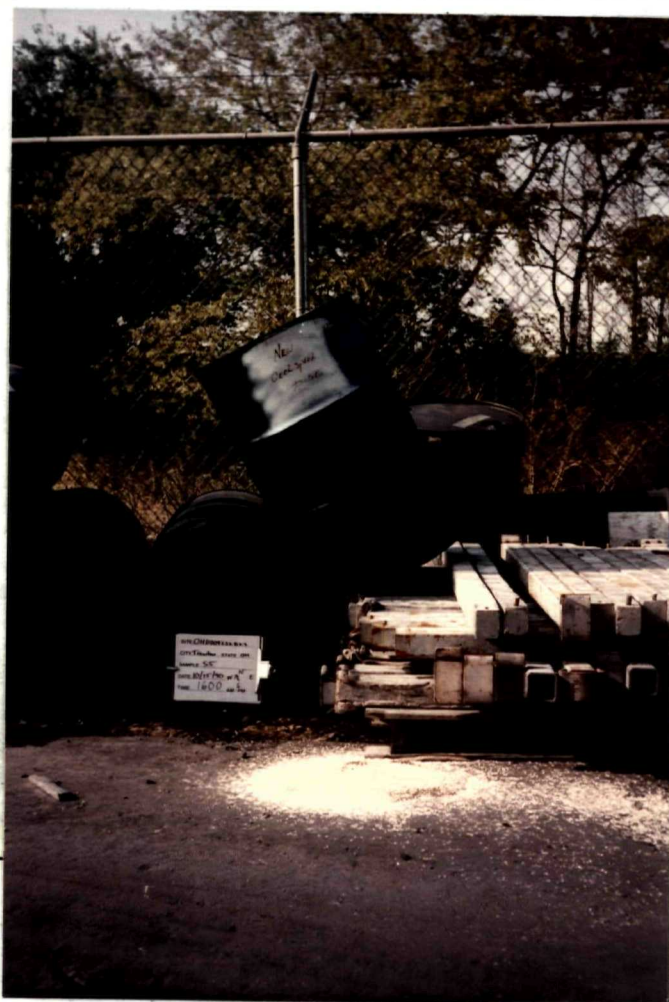
Soil sample S5 was a surface soil sample collected from a 3 foot by 3 foot patch of discolored soil located near drums stored immediately northwest of the aluminum cast storage house. Soil sample S6 was collected as a potential background sample to determine the representative chemical content of the soil in the area of the site. Soil samples S5 and S6 were both collected at depths of approximately 2 to 3 inches. Sampling location S6 was in the bushes adjacent to the northwest corner of the office building.

DESCRIPTION: Close-up of sample 55.

DESCRIPTION: Perspective
view of soil sample 55.

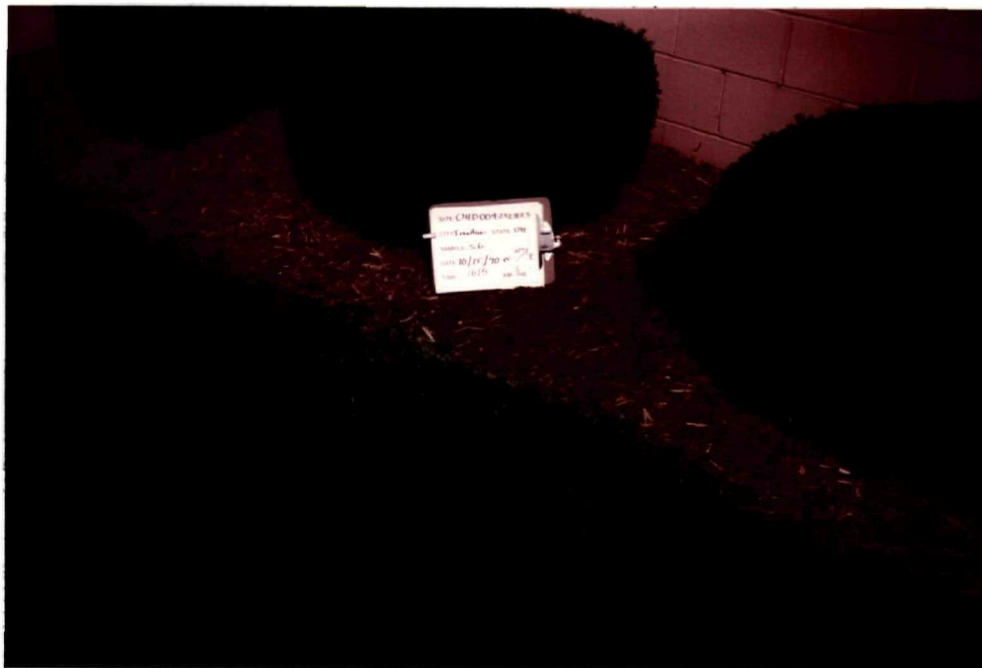
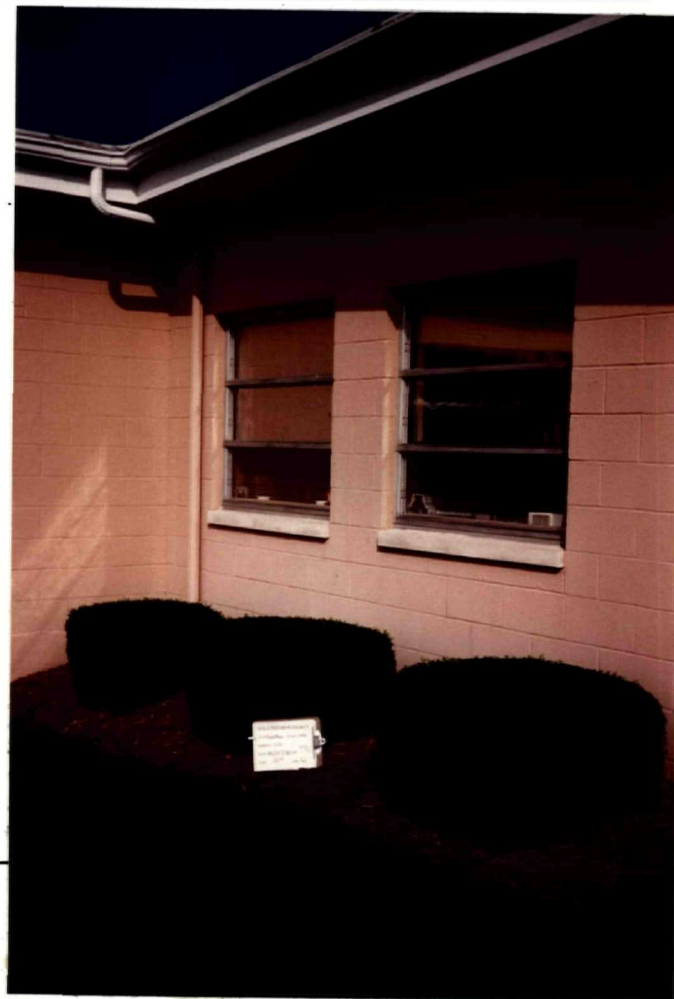
DESCRIPTION: Close-up of sample 56.

DESCRIPTION: Perspective
view of sample 56.

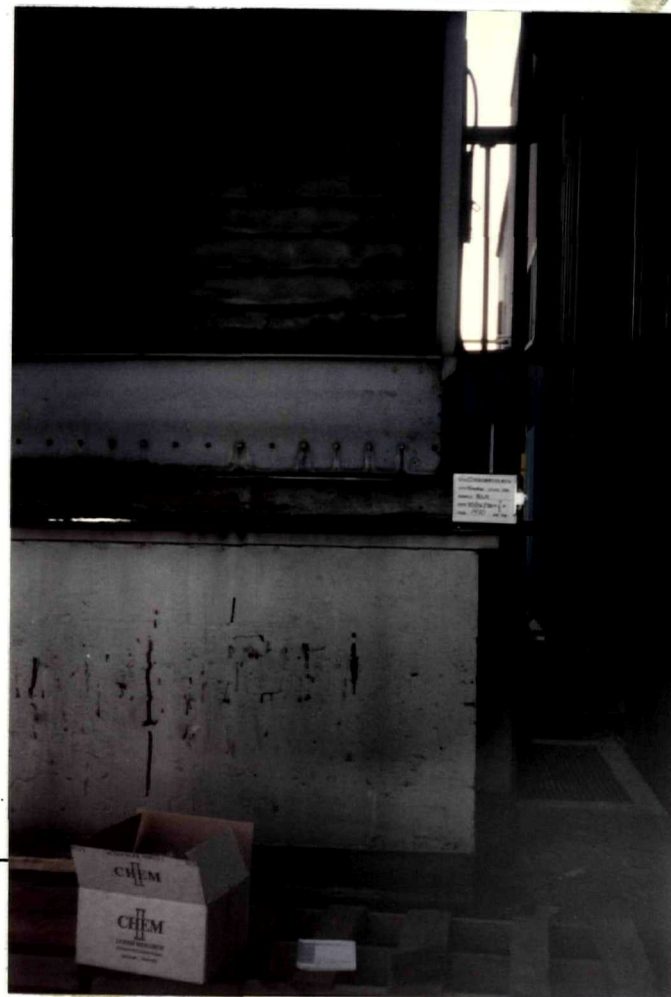
SITE NAME: Magnode Products PAGE 7 OF 16U.S. EPA ID: OH0004232823 TDD: F05-8912-016 PAN: F0405005BDATE: 10/16/90TIME: 1435DIRECTION OF
PHOTOGRAPH:
SouthWEATHER
CONDITIONS:
Clear Sky,
Warm ~ 70°FPHOTOGRAPHED BY:
Mary TierneySAMPLE ID
(if applicable):
RW1DESCRIPTION: Close-up view of residential well sample RW1

DATE: 10/16/90TIME: 1435DIRECTION OF
PHOTOGRAPH: SouthWEATHER
CONDITIONS: Clear Sky, Warm ~ 70°FPHOTOGRAPHED BY: Mary TierneySAMPLE ID
(if applicable): RW1DESCRIPTION: Perspective view
of residential well sample RW1

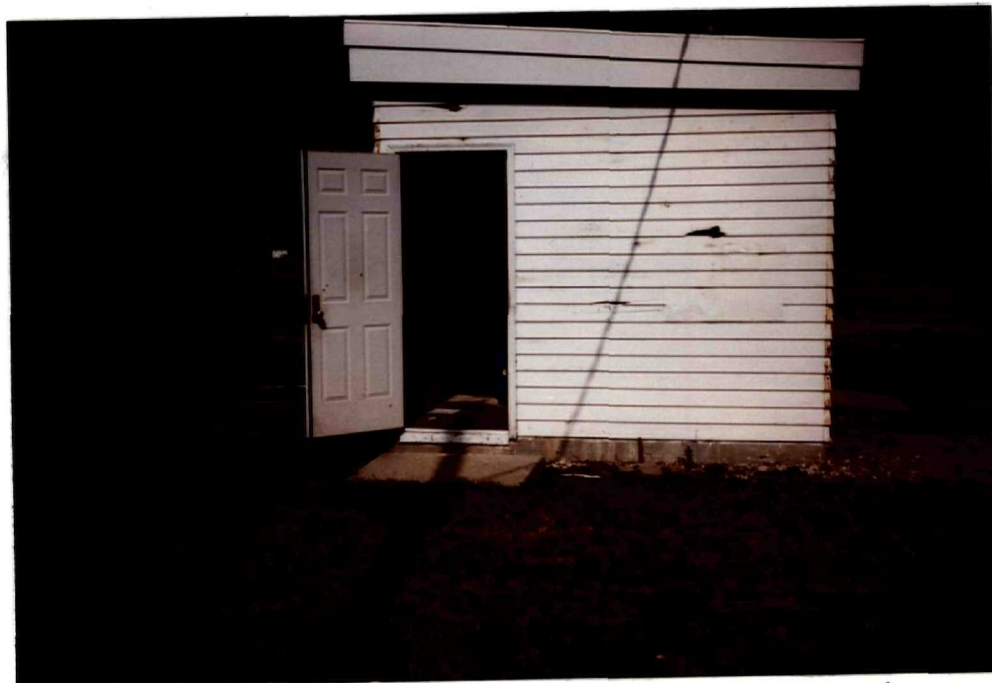
DESCRIPTION: Perspective view of residential well sample RW2

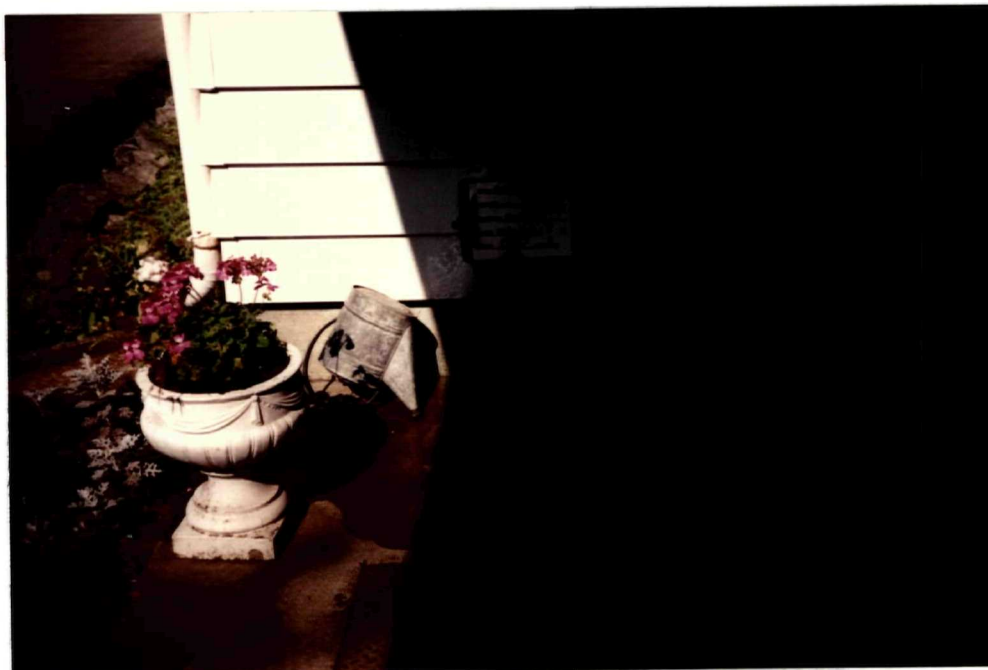
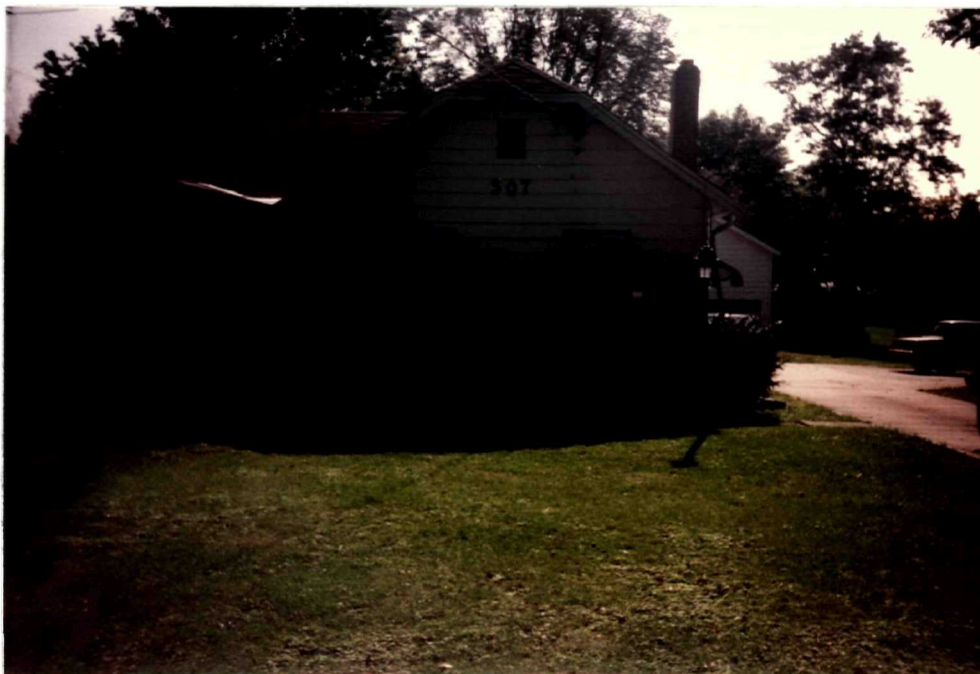
DESCRIPTION: Close-up view of residential well sample RW3

Perspective view of residential well sample RW3.

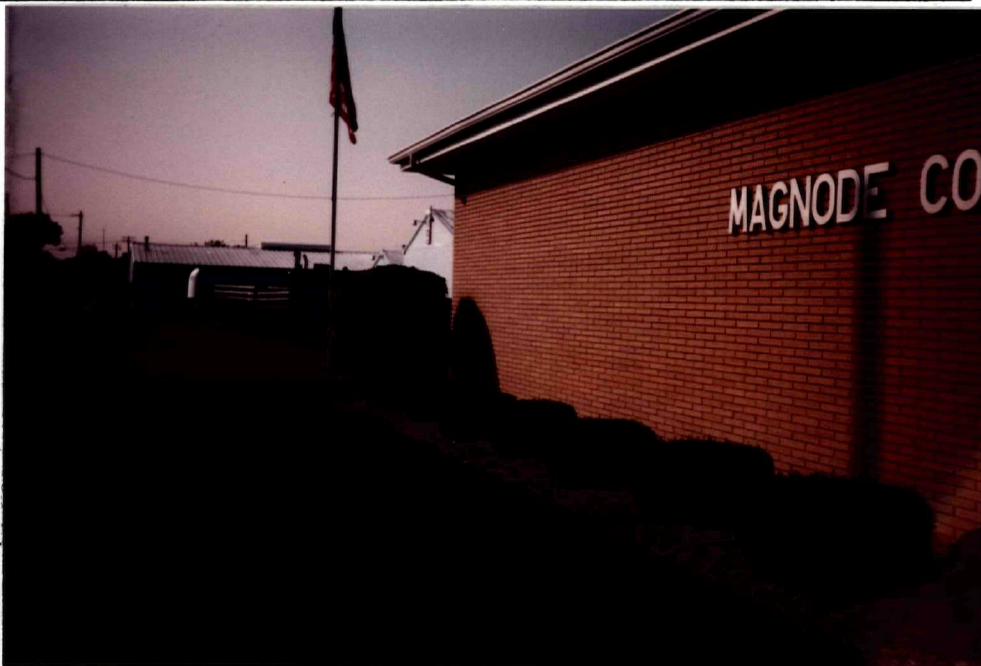
DESCRIPTION: View of front (south side) of site
taken from SE corner.DATE: 10/16/90TIME: 1455DIRECTION OF
PHOTOGRAPH:NorthWEATHER
CONDITIONS:Clear SkyWarm ~ 70°F

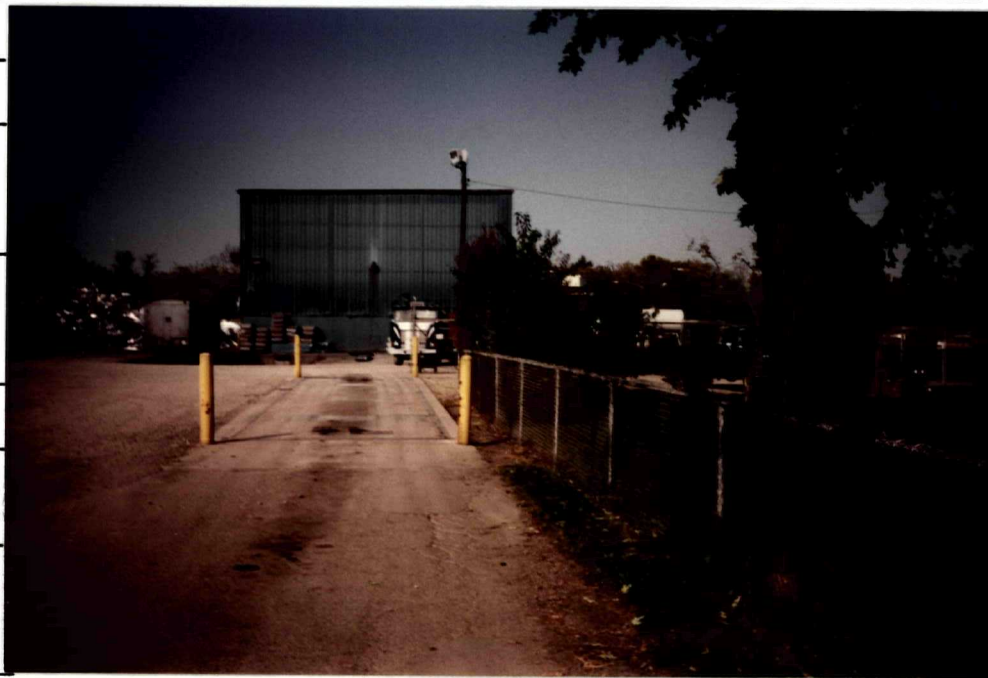
DESCRIPTION: Drive between Magnode offices (left)
and adjacent property to the east (right). Cast
house is in the background.

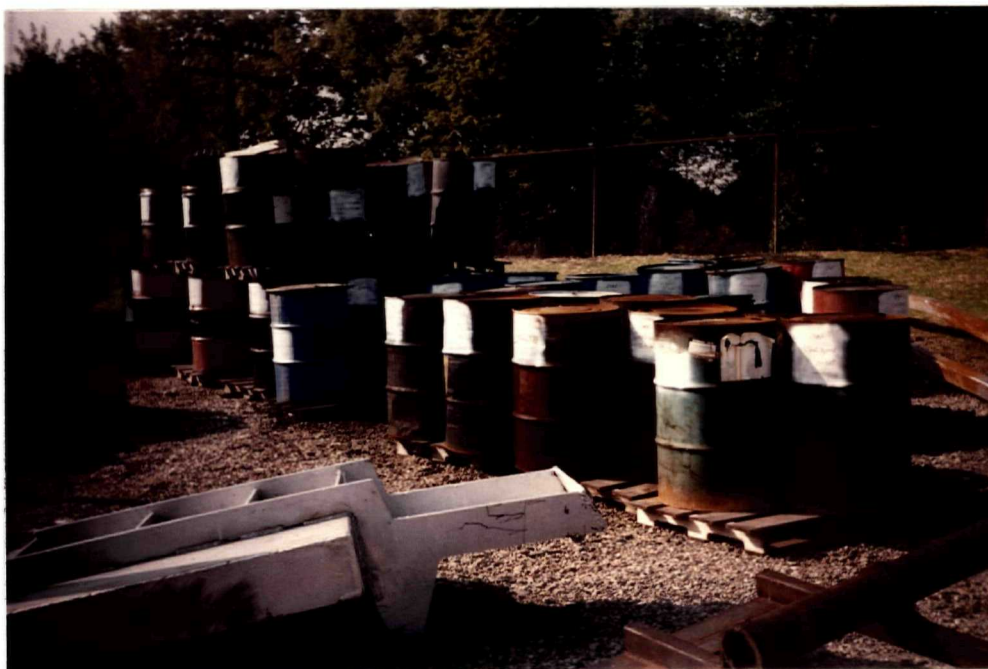
DESCRIPTION: Drums on wooden pallets being stored
northeast of quench ovens.DATE: 10/16/90TIME: 152DIRECTION OF
PHOTOGRAPH: W

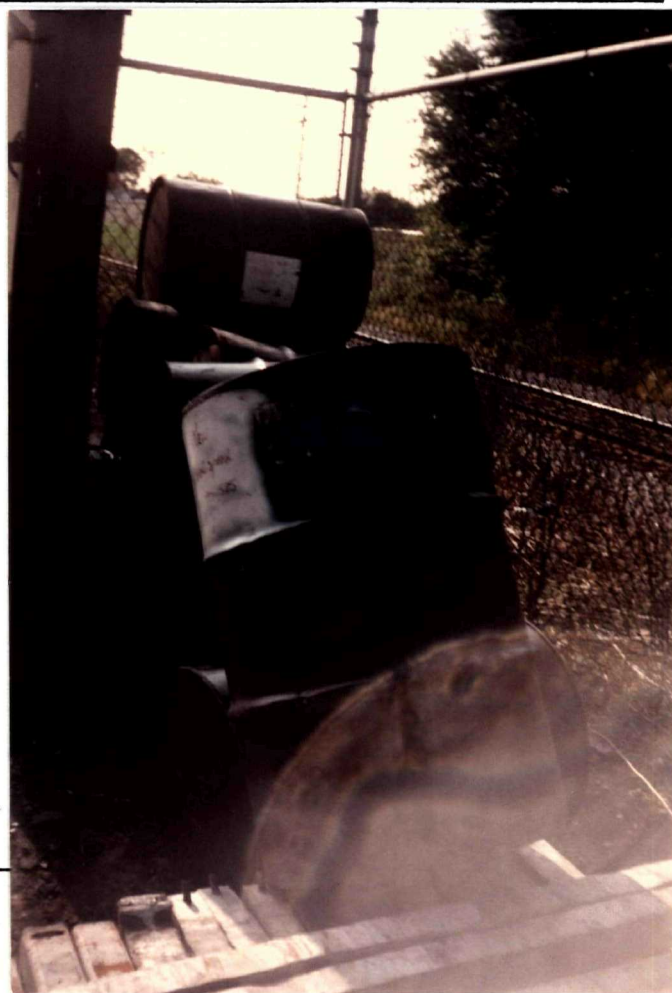
FIT observed steel frames just south of the lagoon in the northeast corner of the site. A 30,000-gallon aboveground storage tank was located east of the steel frames. This storage tank used to contain propane, however, it has since been flushed with nitrogen and is now empty. Scrap aluminum is stored in a scrap pile just west of the aluminum cast storage house, as well as in an employee parking lot in the southwest corner of the site. Although this area is normally used as an employee parking lot, this area is currently being used as a temporary storage area for scrap aluminum because of a large inventory of aluminum scrap. A 6,000-gallon and a 9,000-gallon aboveground storage tank, both containing liquid nitrogen, were located west of the number 5 press building. Approximately 40 rusty, empty drums were observed on wooden pallets approximately 20 feet northeast of the two quench water ovens. Most of these drums had contained cutting oil (Adams et al 1990). Approximately 10 empty drums were observed just northwest of the aluminum cast storage house and along the northwest fence. These drums allegedly contained cutting oil. Several of these drums were lying on their sides on a small patch of black soil.

CONDITIONS: Clear Sky, Warm ~ 70°FPHOTOGRAPHED BY: Mary TierneySAMPLE ID
(if applicable): -DESCRIPTION: Drums adjacent
to north fence line north
of the cast house. Drums
were standing on
small patch of dis-
colored soil.

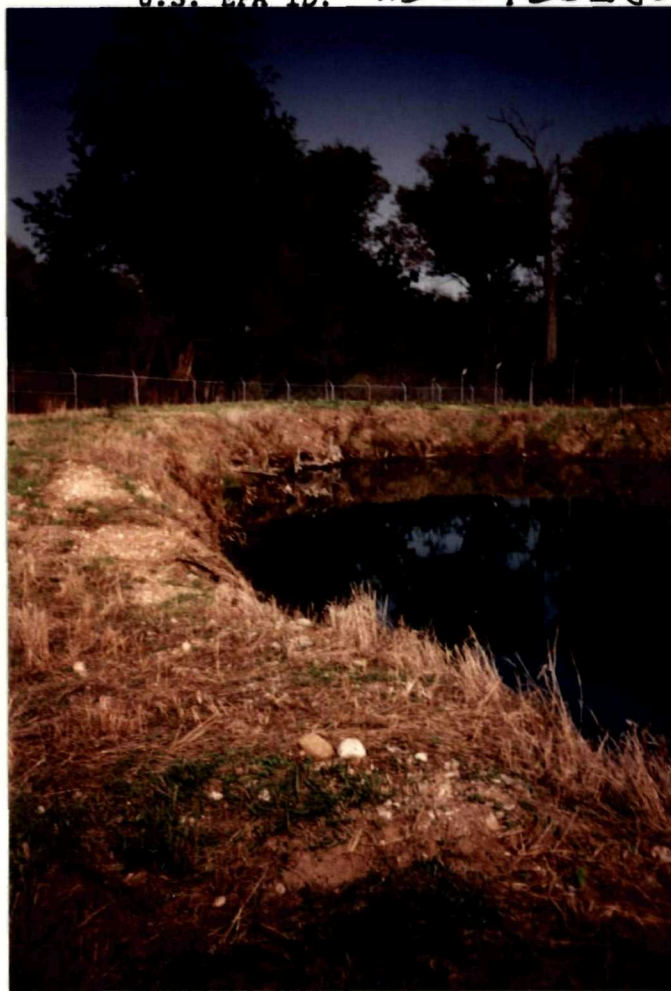
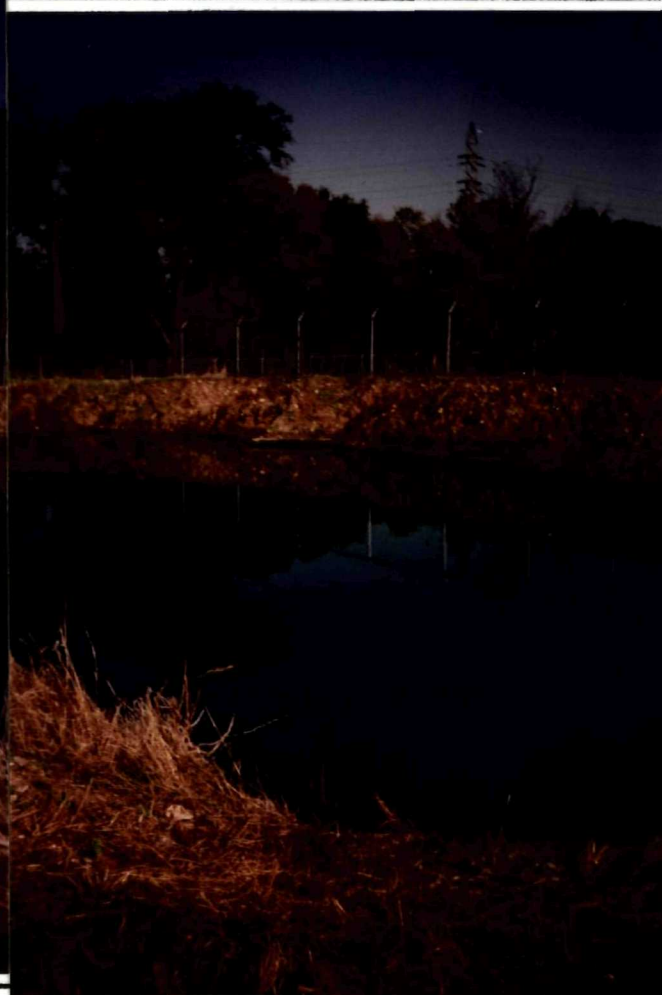
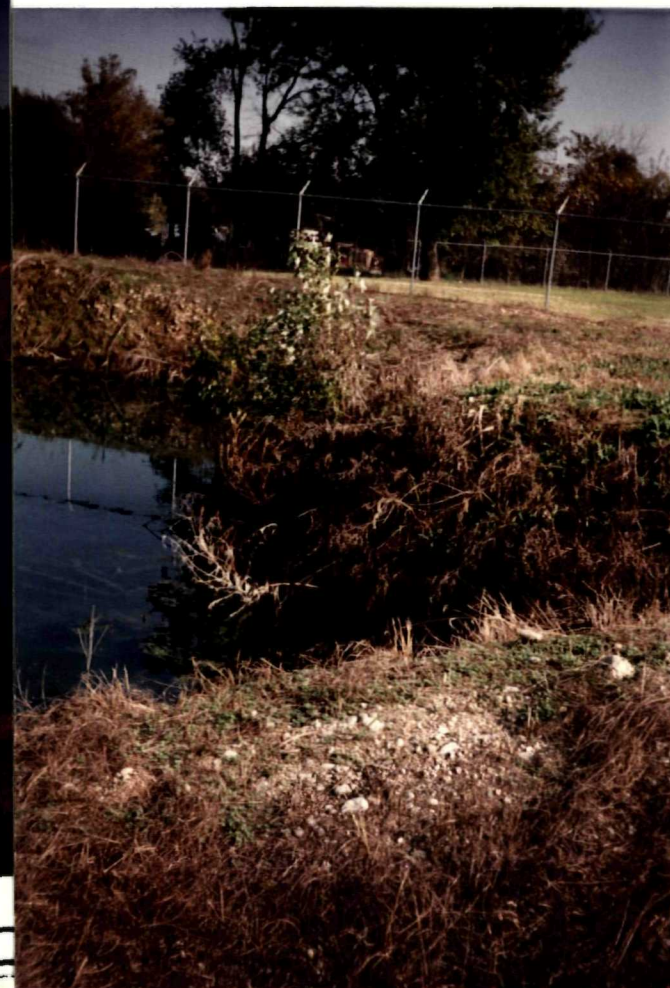
The active lagoon, which is approximately 100 feet long by 40 feet wide and 10 to 12 feet deep, is in the northwestern corner of the site. The lagoon is unlined and has steeply sloped banks. The water level was approximately 3 feet below ground level at the time of the FIT SSI. The water in the lagoon was very clear. FIT observed algae-covered metal debris near the lagoon's northern edge. Several turtles and frogs were observed by FIT in and around the lagoon.

DATE: >10/16/90 TIME: >1518 DIRECTION OF PHOTOGRAPH: >SE to NE PHOTOGRAPHED BY: >MARY TIERNEY
 WEATHER CONDITIONS: >clear sky, warm, ~70°F SAMPLE ID (if applicable): >-
 DESCRIPTION: >Panorama of lagoon taken from northwest edge.

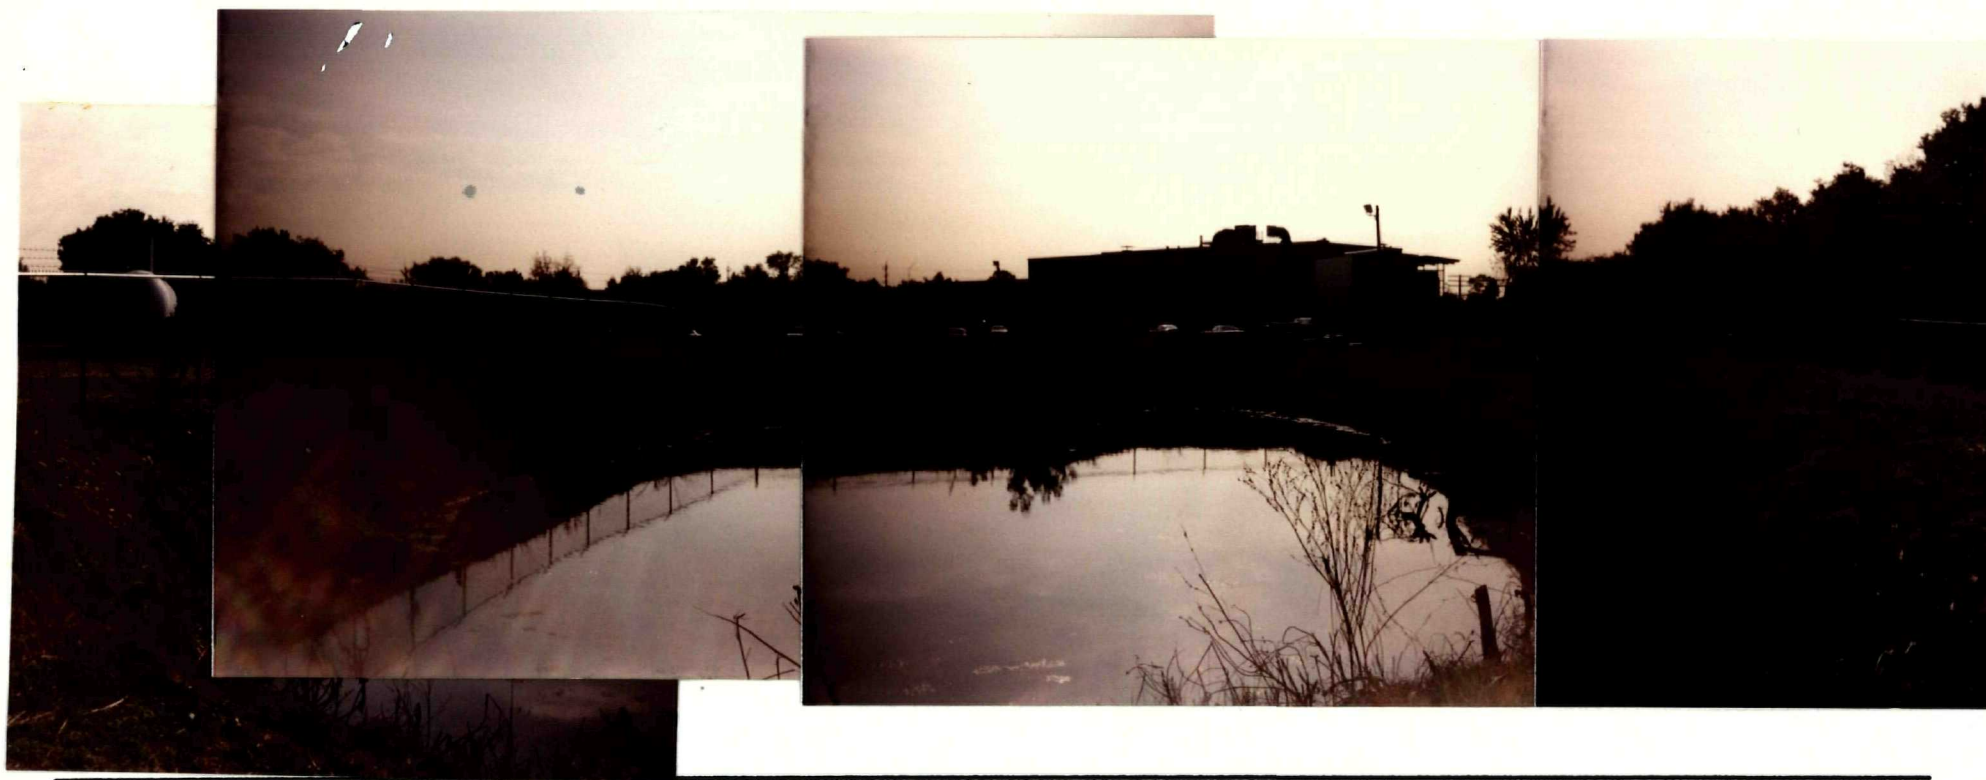
DATE: > 10/16/90 TIME: > 1715 DIRECTION OF PHOTOGRAPH: > SW to NW PHOTOGRAPHED BY: > Mary Tierney

WEATHER CONDITIONS: > clear sky, warm, ~70°F SAMPLE ID (if applicable): > -

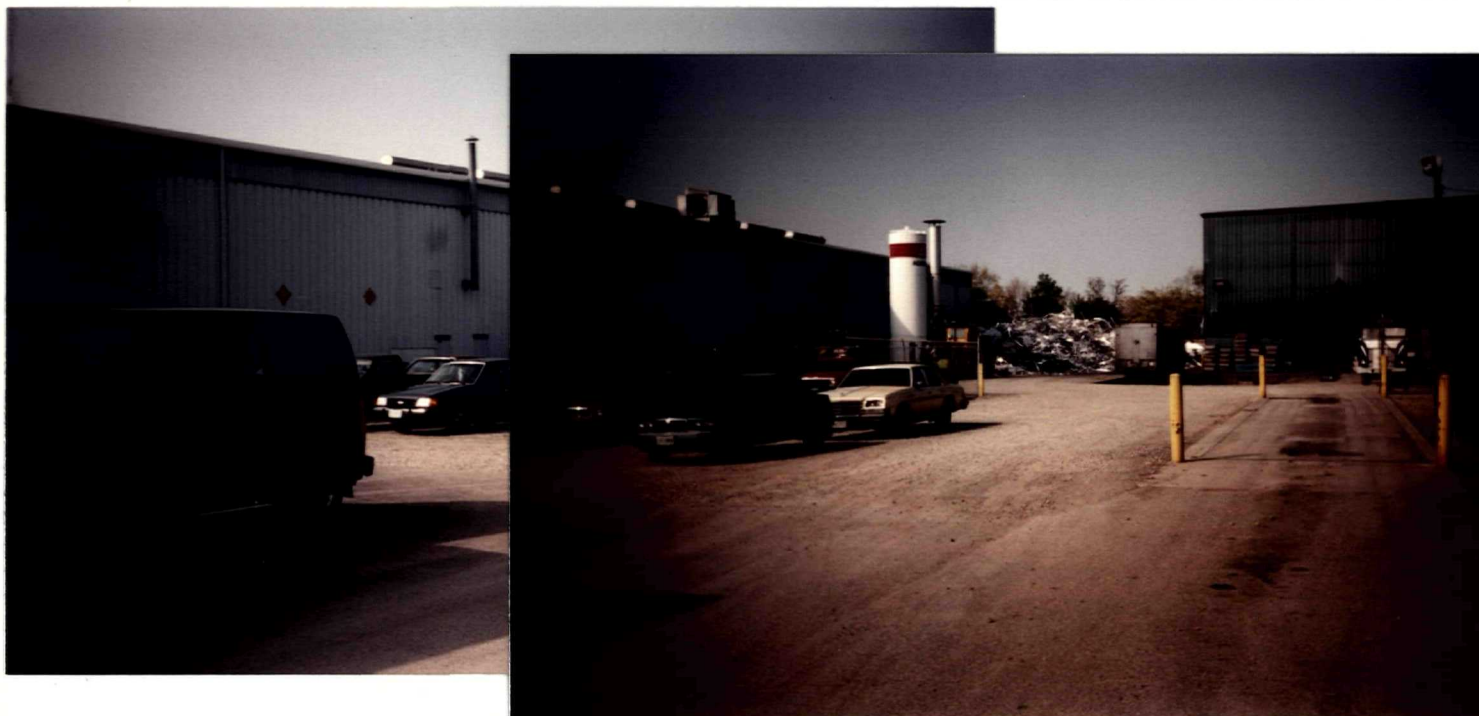
DATE: > 10/16/90 TIME: > 1500 DIRECTION OF PHOTOGRAPH: > NW to N PHOTOGRAPHED BY: > Mary Tierney

WEATHER CONDITIONS: > clear sky, warm, ~70°F SAMPLE ID (if applicable): > -

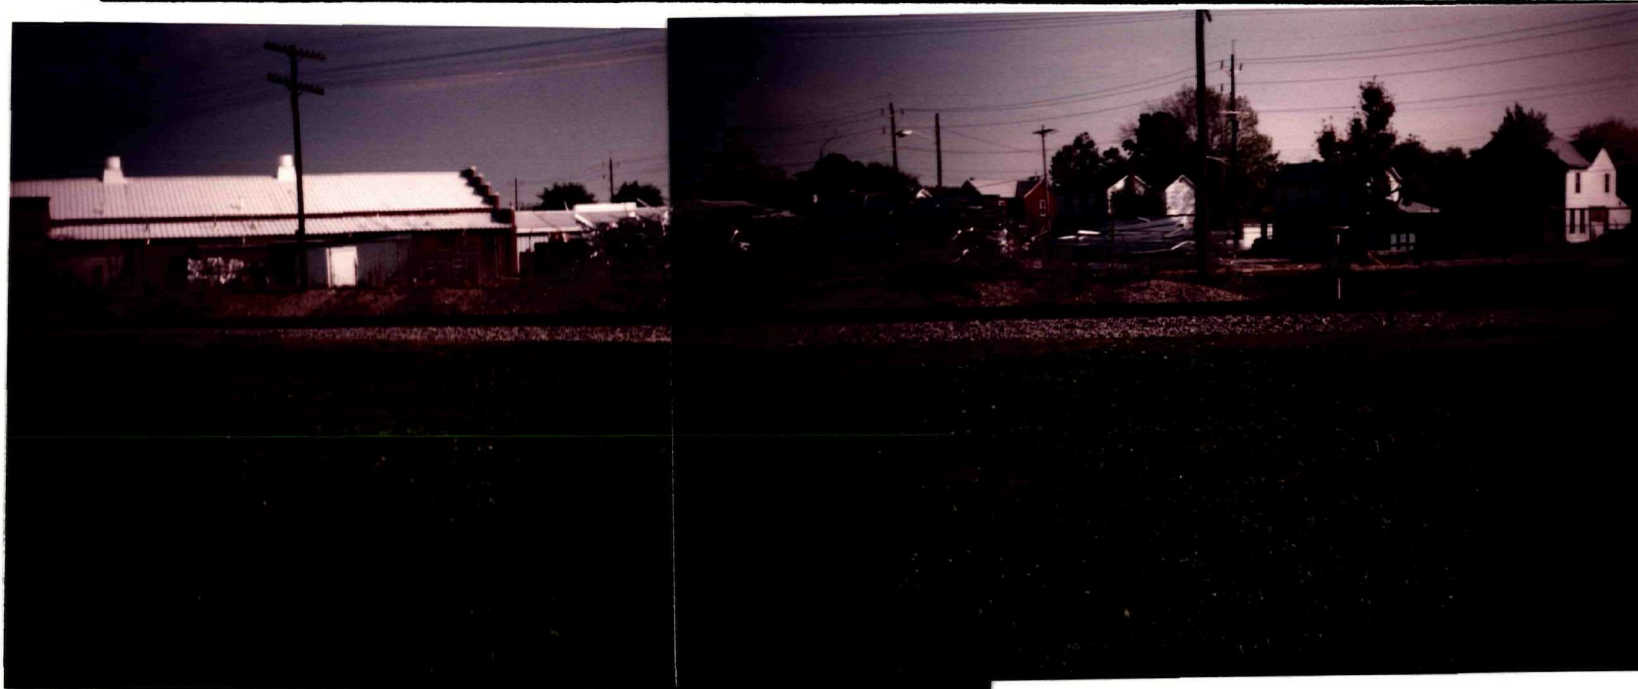
DATE: > 10/16/90 TIME: > 1535 DIRECTION OF PHOTOGRAPH: > SE PHOTOGRAPHED BY: > Mary Tierney

WEATHER CONDITIONS: > clear sky, warm, ~70°F SAMPLE ID (if applicable): > -

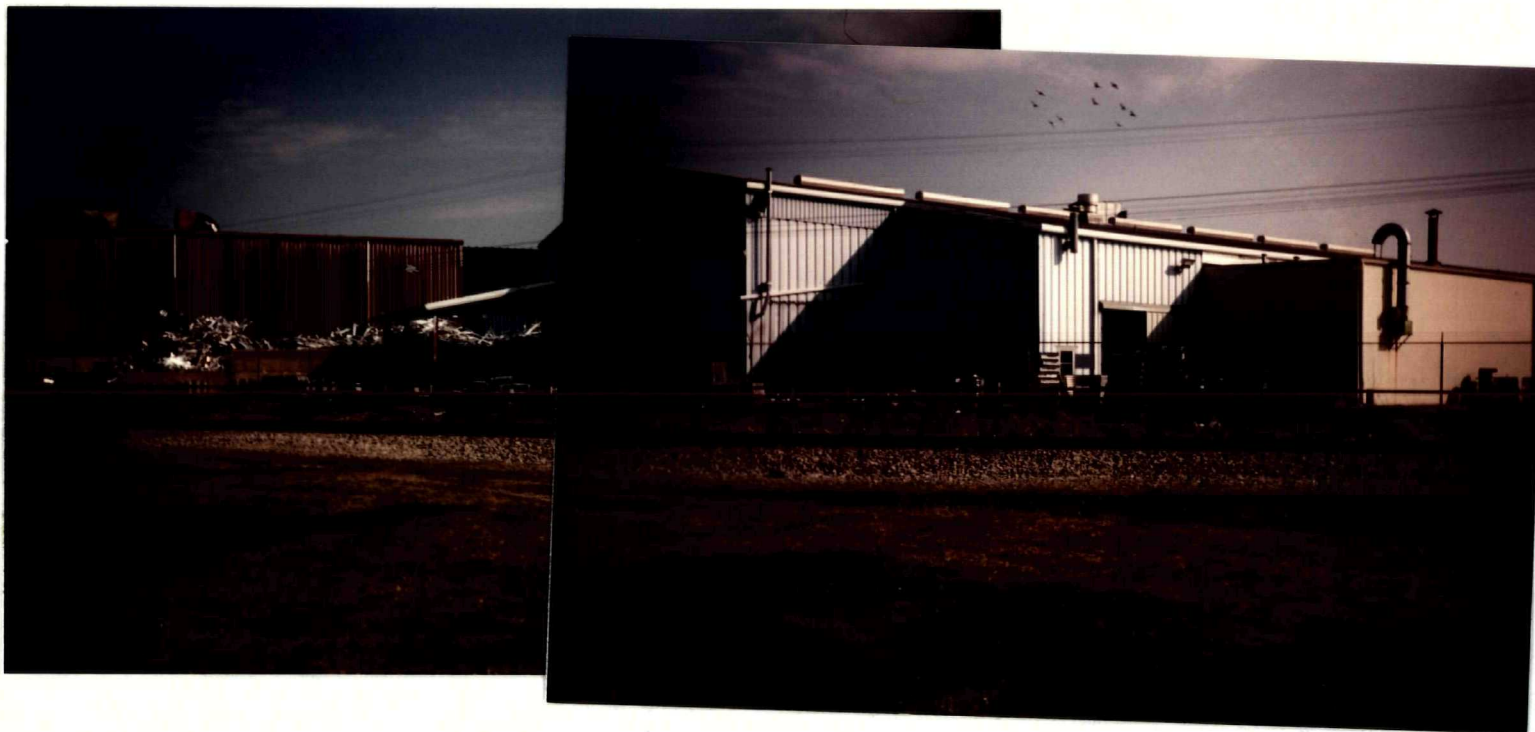
DATE: > 10/16/90 TIME: > 1535 DIRECTION OF PHOTOGRAPH: > ESE to SSE PHOTOGRAPHED BY: > Mary Tierney

WEATHER CONDITIONS: > clear sky, warm, ~70°F SAMPLE ID (if applicable): > -
